FIRE AND ROCK ART

David Lambert and Brad Welsh

Abstract. Case examples are given where intense heat from fire resulted in significant damage to Australian rock art sites. Conservation and management strategies are discussed.

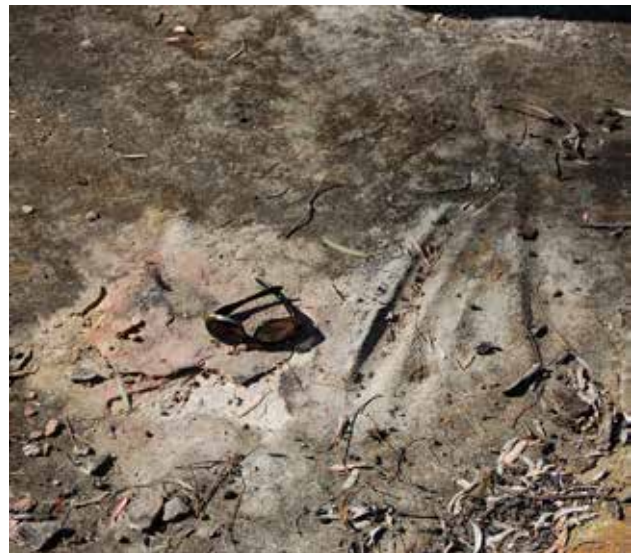
The axe-grinding groove at a site near Narrabri is shown in Figure 1. This shows damage caused by a campfire, which has been established directly on the sandstone. The implication here is that hot and sustained fire will cause sandstone to become friable. Note that only the immediate area of the fire is impacted.

Figure 1. Damage to an axe grinding groove site near Narrabri, NSW. The damage has been caused by a campfire set directly on the sandstone. Note that damage is confined to areas of long exposure to intense heat (photograph by Craig Trindle).

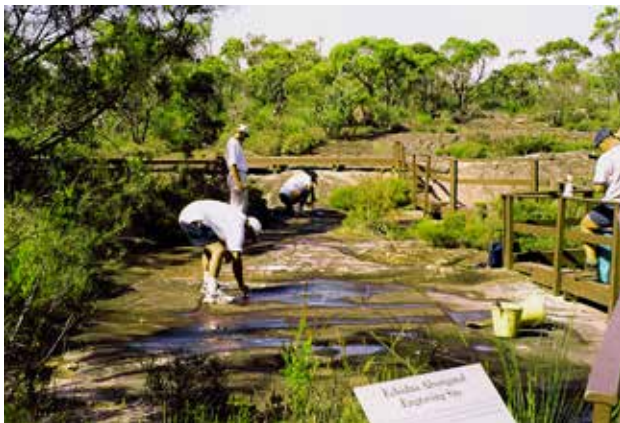
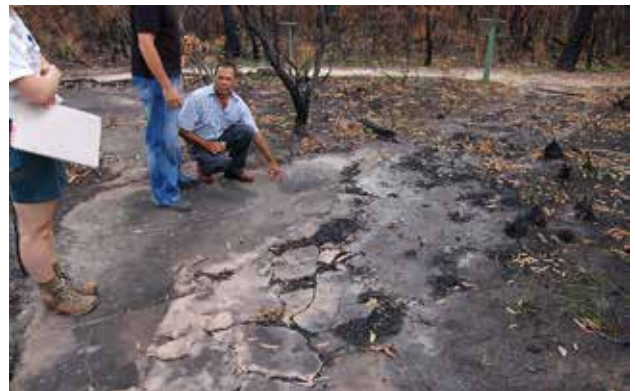
This site is known as the Echidna Site and had a wooden boardwalk constructed for visitor and wheel chair access. In this case the boardwalk caught fire during a summer bush fire event and the heat

Figure 2. Echidna Site showing the boardwalk before the fire event.

Figure 3. The same site after the fire. Note that damage to the sandstone is confined to the location of the former boardwalk.

generated was sufficient to cause similar damage to the example shown above (Figs 2 and 3).

Clearly, new boardwalks should no longer be constructed using combustible material, and old wooden boardwalks need to eventually be replaced with a non-combustible material or design.

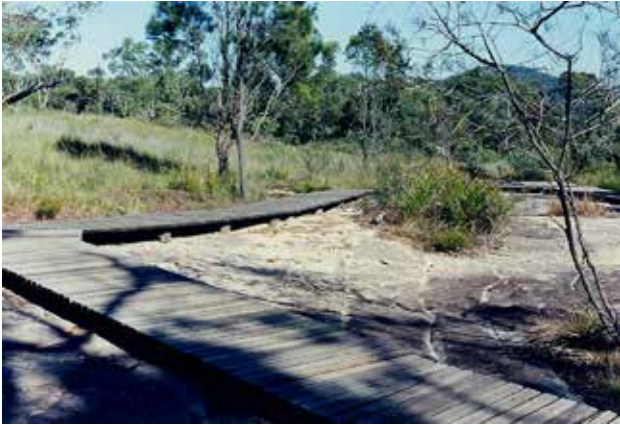
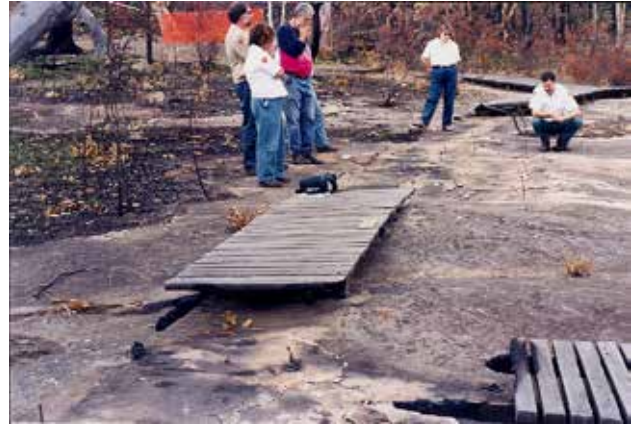
Figure 4. The boardwalk before the fire at the Bulgandry petroglyph site near Gosford, New South Wales.

Figure 5. The same site after the fire. Note that damage to the sandstone is confined to the location of the former boardwalk.

This example is similar to the Echidna Site above. This was a hardwood boardwalk constructed in the late 1970s. Again, the intense heat generated from the burning wood, which was approximately 10 cm above the rock surface, was sufficient to disrupt the sandstone fabric (Figs 4 and 5).

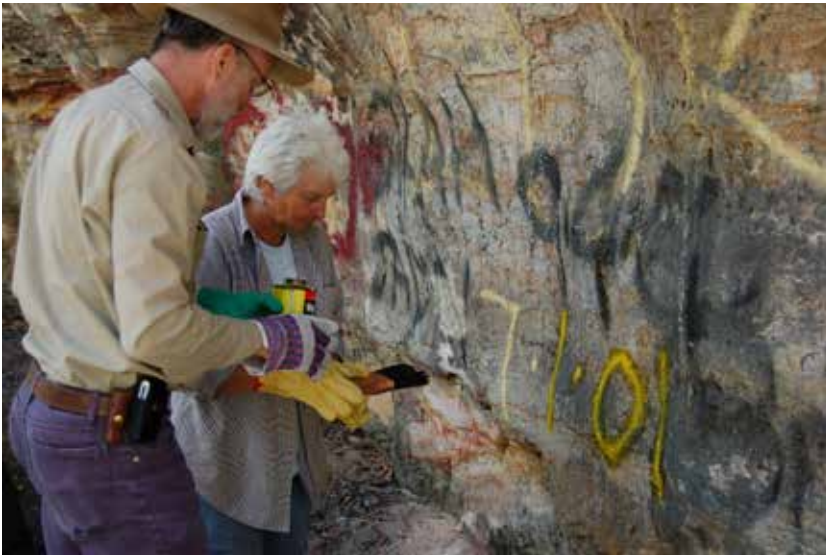
Figure 6. A vandalised rock art site in the Blue Mountains where a vehicle was set on fire. Note that the fire damage is significant but confined to the area of intense heat.

This site is located adjacent to a public road but is an isolated part of the Blue Mountains west of Sydney, New South Wales. The site has suffered heavy paint graffiti and other vandalism. In addition, a stolen car was driven into the shelter and set on fire. The extreme heat generated has caused localised irreversible damage to the rock fabric. A metre or so away, however, the rock fabric within the shelter remains sound (Fig. 6).

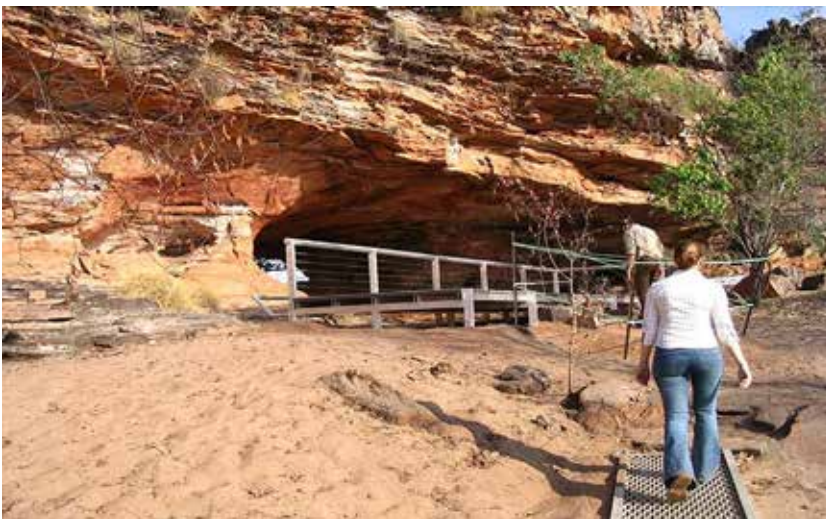
Figure 7. The Northern Territory rock art shelter before the fire.

This example is from a major sandstone art shelter in the Northern Territory. In this case, the boardwalk was made from a recycled plastic material. As can be seen from Figure 7, there is little ground fuel to support a hot bush fire. In this case the fire was intended to be a hazard reduction burn. The result was that

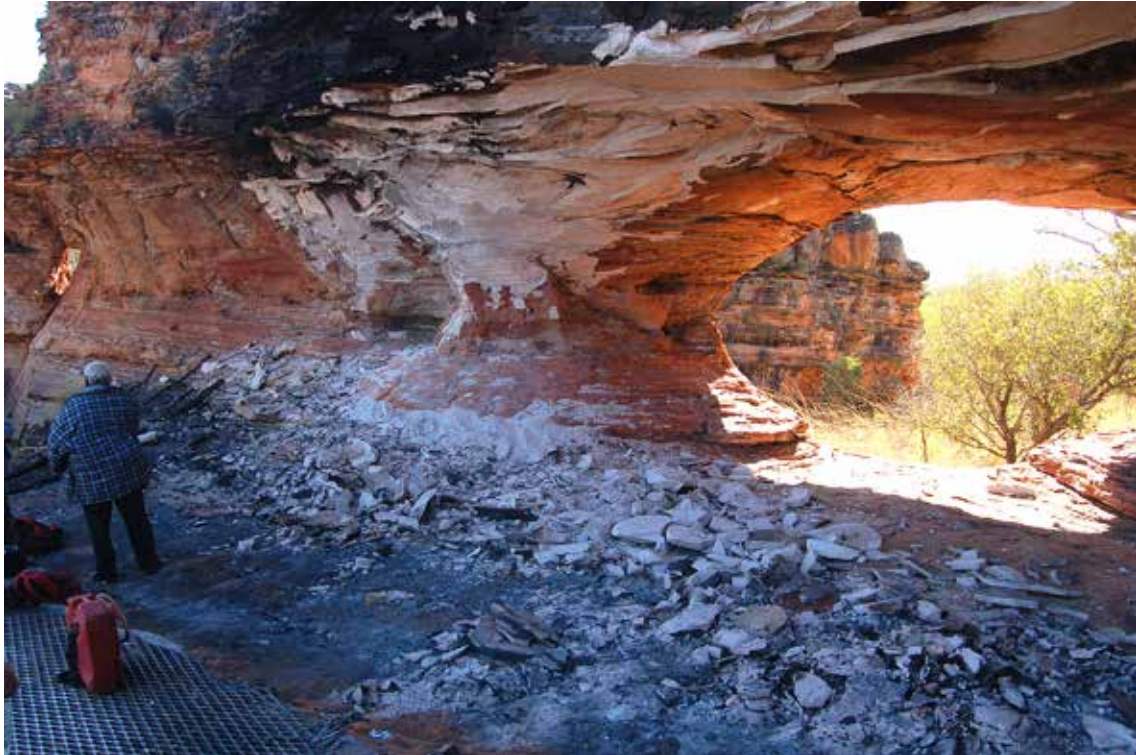
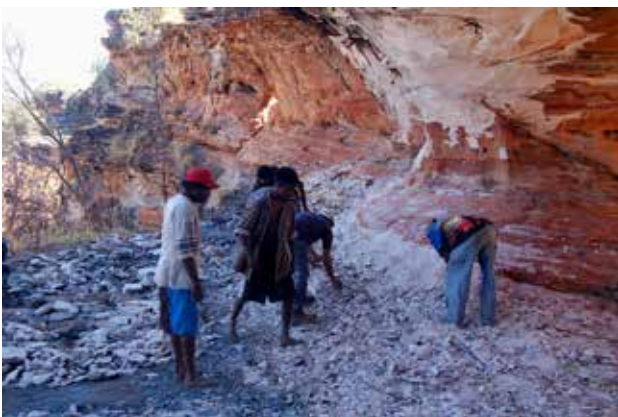
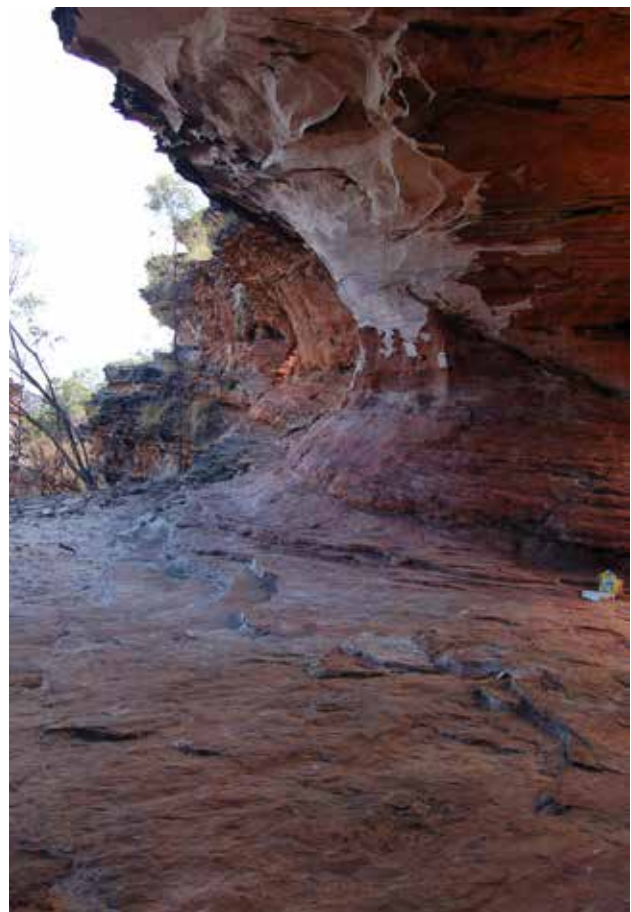
Figure 8. Fire damage has resulted in the loss of valuable paintings. The shattered sandstone on the floor of the shelter was considered unsalvageable.

once the plastic material ignited, the severe heat generated caused the painted rock surface to shatter and disintegrate, falling to the floor of the shelter. The follow up conservation action in consultation with Traditional Owners was confined essentially to a clean up, placing the shattered material near the entrance of the shelter and to initiate baseline monitoring to assess the need for any future intervention (Figs 8 to 10).

Figure 9. Traditional owners working to remove shattered material from the floor so that the shelter can again be used.

Figure 10. The site after washing. Note the site is now closed to public viewing.

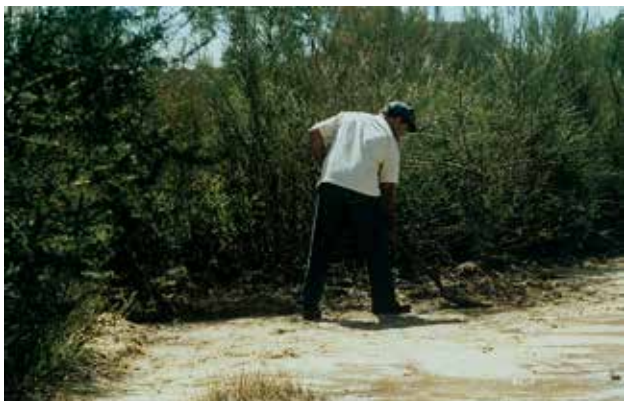
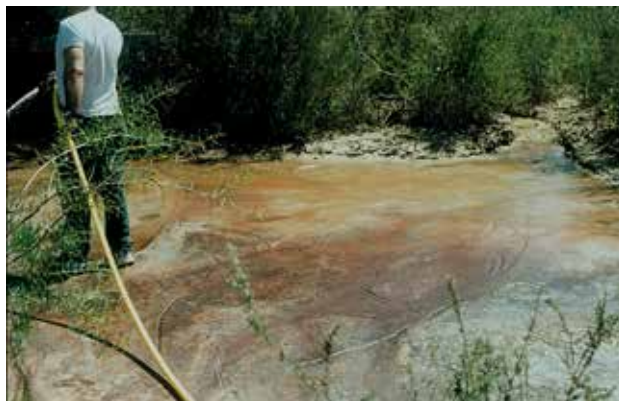
In the Sydney sandstone, there is clear evidence of encroaching soil on petroglyph sites (Figs 11 and 12). Along with that comes highly combustible vegetation. Accordingly, site management needs to address this as a maintenance issue.

Figure 11. Brad Welsh removing soil which is encroaching an petroglyph site at Ku-ring gai Chase National Park, Sydney.

Figure 12. Local Aboriginal Land Council member washing the site to remove the soil close to the rock surface. Note that drainage areas have been dug to allow runoff to escape from the site.

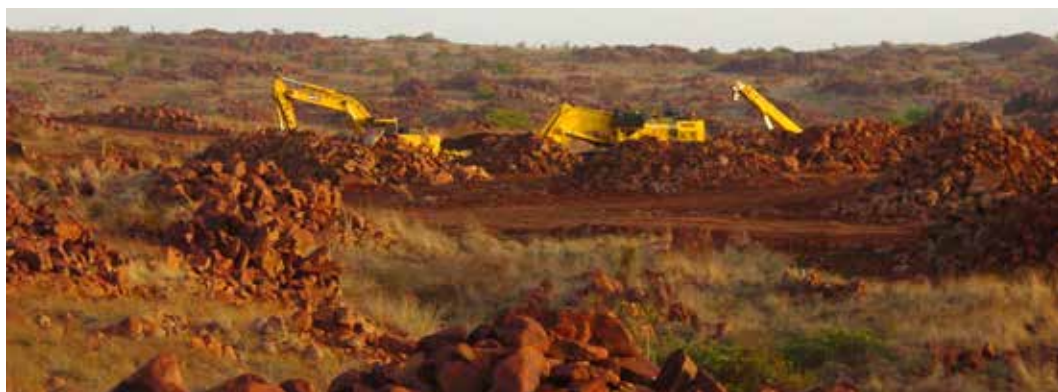
Destruction of Dampier rock art site at Holden Point on 7 February 2007; photograph taken secretly by campaign activist.
