PROTECTION OF SCANDINAVIAN ROCK ART USING MARINE CLAY

Eva Ernfridsson, Per Hagelia, Gro Anita Bårdseth,
Tanaquil Enzensberger and Kristin Marie Berg

Abstract. When a new highway in SE Norway was planned in 2003, five petroglyph sites, located in the immediate surroundings of the road, were to be permanently covered. The covers consist of c. 70-cm-thick layers of plastic Quaternary marine clay on the rock art, followed by a geotextile, a thin drainage layer of natural gravel and finally a rather thick top layer of cobble stones. The clay serves to sustain a stable temperature, humidity and circum-neutral pH at the rock surface and to prevent the establishment of plant roots. The purpose of the covers was to prevent increased deterioration rates of the rock art due to emissions from traffic and action from de-icing salts used on the road. This paper presents the cover design developed for this project, based on principles from the geotechnical, geochemical, biological and conservation fields. Subsequently, the paper demonstrates the success of a cross-disciplinary approach to rock art protection.

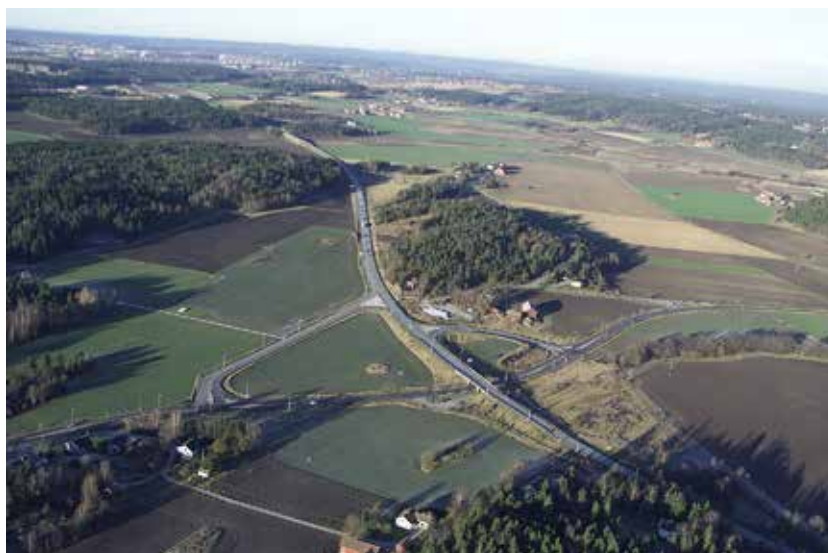
Figure 2. Aerial view of the southernmost part of the research area, before the completion of the new highway. The rock art sites are located on rock exposures close to the road. Photograph: The Norwegian Public Roads Administration.

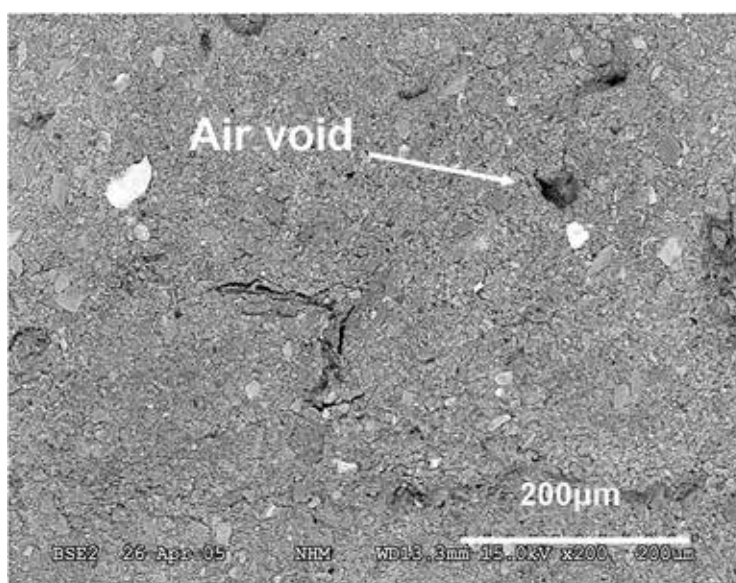
Figure 3. ESEM of the plastic clay sample M2. Notice the overall dense micro-structure with occasional non-connecting air voids reaching 30 microns. Photograph: Hans-Jørgen Berg.

The SEM results show that total sulphur contents varied from 0–1.2 weight %, whilst Fe was much more abundant than pyrite can account for. There was also a little chloride present, ranging from 0 to 0.02 and occasionally 0.35 weight per cent in single points analysed. Hence most likely both sulphur and chloride represent old seawater. SEM imaging showed that samples of plastic clay were in fact dense, occasionally containing voids <30 μm , which according to experience makes it very inaccessible to root penetration (Fig. 3).

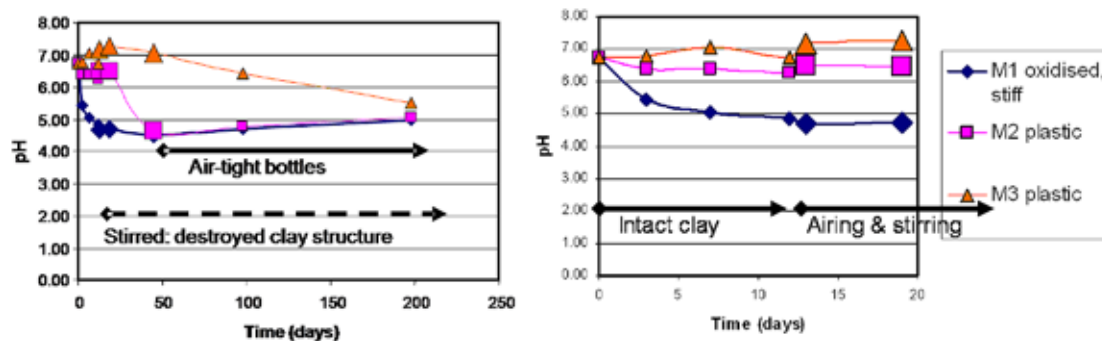
Figure 4. Evolution of pH in the static leaching experiment under varied imposed conditions. The intact plastic clay levelled off at a circum-neutral pH while airtight, whilst oxidised stiff clay reacted with acidification. Later severe stirring and destruction of clay structure caused variable degree of acidification in the long run.

Left: total experiment; right: first 20 days, representing the properties in final cover. Graphics: Per Hagelia.

Lumps of 100 ml from each clay sample were put into 500 ml plastic bottles and filled with about 400 ml of very low ionic tap water before capping (using an inner and outer lid). In the first part of this static leaching experiment the bottles were capped and airtight, and the clay lumps were kept intact by very careful treatment of the bottles during measurement. Under these conditions the aqueous pH of plastic clay (M2 and M3) levels off at circum-neutral values. In contrast, the oxidised and stiffer clay (M1) developed acidity, reaching pH = 4.7 after 12 days. After the measurements on day 12, all bottles were stirred very well several times and kept open to air for one month. This treatment involved disintegration of clay leaving much material in suspension. The motivation was to expose the clay to oxidised water and establish the ultimate potential effects in case of unwanted destabilisation of the protective layer. It was discovered that, although pH remained fairly constant in each bottle for at least one week after stirring and continuous airing (until day 19), also the initially plastic clays (notably sample M2) had a capacity to develop acidity. This was accompanied with quite heavy deposition of rusty iron compounds in all bottles (first M1, followed by M2, with extensive rust development also in M3 by day 45). Yet, after recapping and settlement of clay particles, pH started to rise gently in M1 and M2, converging with the still dropping M3 at pH about 5–5.5 on day 198 (see Figure 4). This was controlled on day 336 showing: pH (M1) = 5.4; pH (M2) = 5.5 and pH (M3) = 5.6 (not plotted).

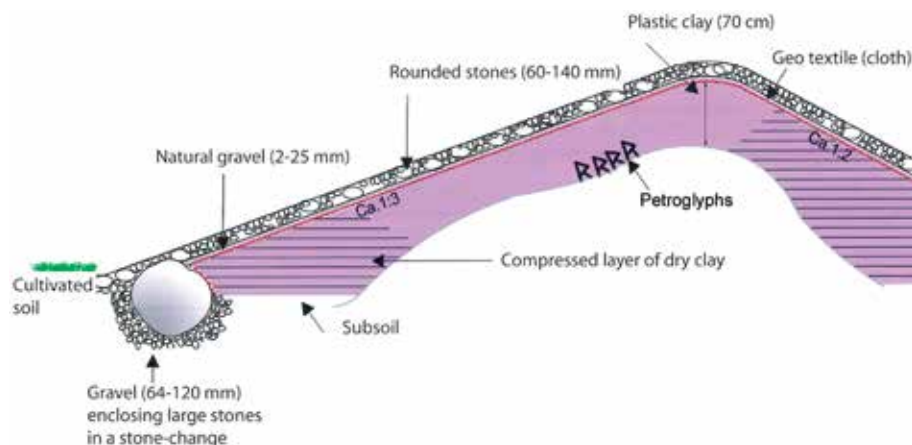
Figure 5. The principles of the covering. Graphics: Kristin Marie Berg.

to avert these changes from extending deeper into the clay. A decision was made to construct a thin mid-layer of natural gravel (2–25 mm fraction). Another possibility was to choose crushed rocks, such as rubble or shingle instead of natural gravel, but the vegetation advisor argued that there would be less corrosion on the natural gravel than on the crushed rocks. It was, however, a requirement that the smallest sand grains were to be sieved out; to make sure this mid layer would not become a healthy cultivation environment for plants. Figure 5 shows a sketch of the construction.

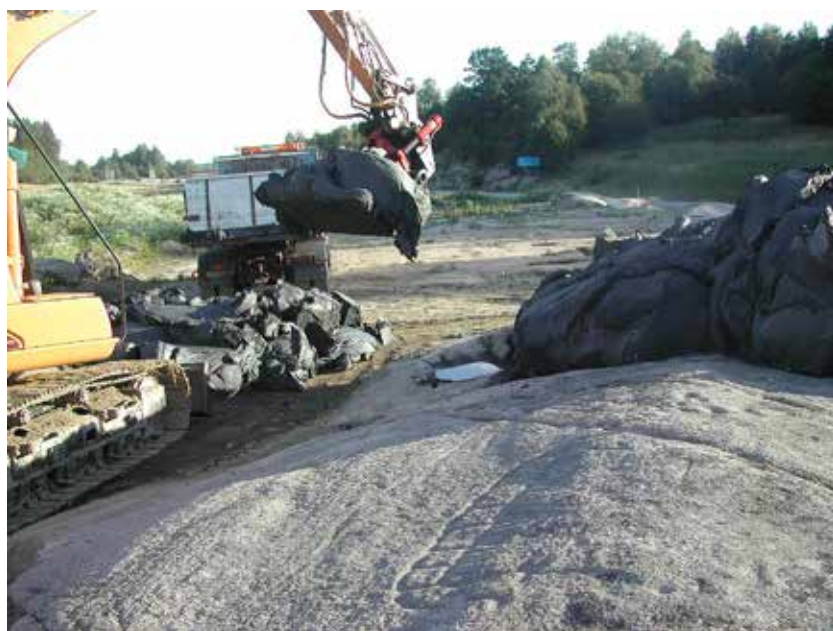
Figure 6. Adding of marine clay to a rock art site. The depictions at the site consist of several large 'ships', of which one is visible on the photograph, and numerous cupules. Photograph: Ingrid Aune, SA.

Four sites were covered in the autumn of 2005, and one site was covered in the autumn of 2006 (Figs 6, 7, 8, 9 and 10).

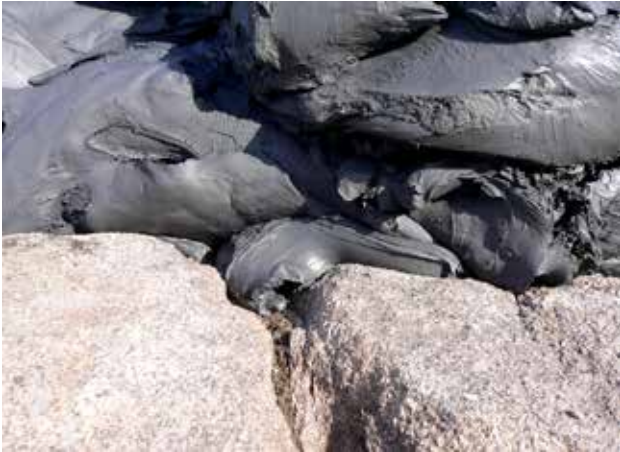
Figure 7. The marine clay filled all the fissures in the rock, as a result of its plastic character. Photograph: Gro Anita Bårdseth.

the clay was somewhat self compressing, being very plastic. The clay instantly flowed into every fissure and hollow, filling them. Further compression was, however, not possible as the clay was too soft. The shuffle on the digger was used to level the clay surface as much as possible. The experience from this project showed that slopes with an angle steeper than 1:3 should not be included. If supportive fillings made of dry clay are used where there are larger differences in height, these can be built with an angle of 1:2 stretching over a 5-metre area.

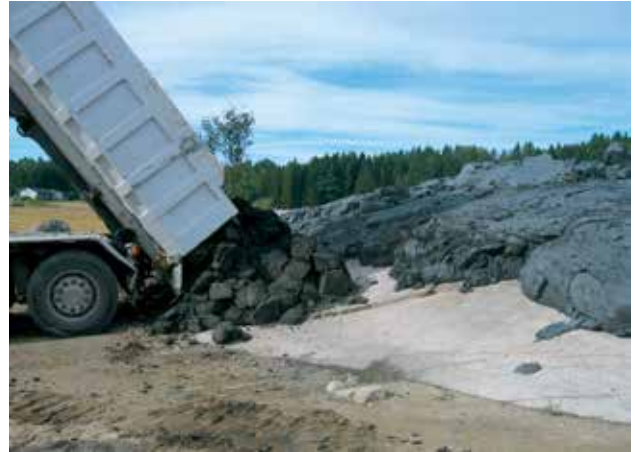
Figure 8. Dumping of dry clay in front of the marine clay, for the construction of supportive fillings. Photograph: Kristin Marie Berg.

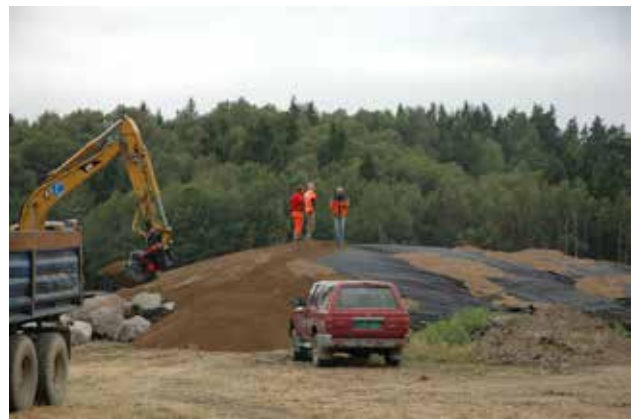
Figure 9. The geotextile (black fibre cloth) covers the layer of marine clay, and the dumping of natural gravel is under progress. Photograph: Gro Anita Bårdseth.

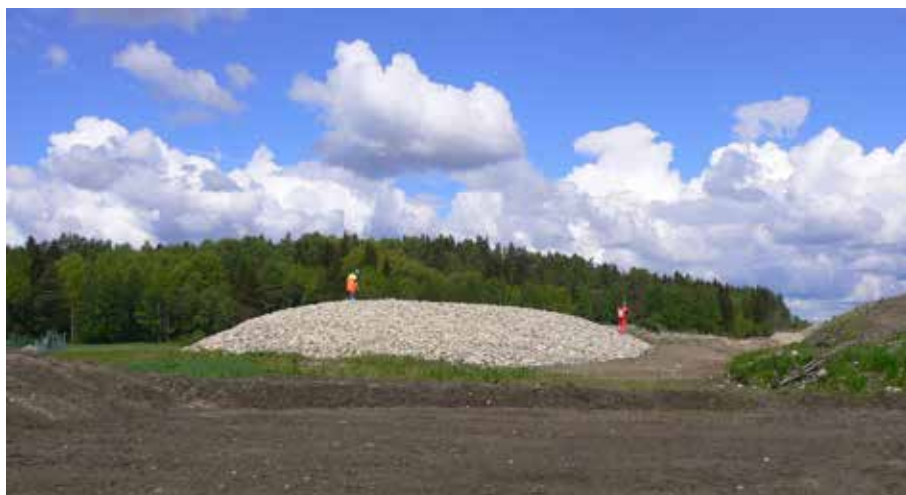
Figure 10. A covered rock art site. The highway is still under construction, but after completion it passes directly in front of the covered site. Photograph: Gro Anita Bårdseth.
